EAST BOSTON STEAM PUMP STATION
20 Addison Street
Boston
Suffolk County
Massachusetts

HAER No. MA-128

EAST BOSTON STEAM PUMP STATION

This documentation was extracted from the East Boston Pumping Station: Historical, Architectural, Structural and Geotechnical Assessment, dated September 18, 1992 as prepared by Metcalf and Eddy in association with Ann Beha Associates. The assessment was completed in compliance with the National Historic Preservation Act (36 CFR 800) and M.G.L. Ch. 9, ss. 26-27c, as amended (950 CMR 71). The Authority is proposing to demolish the two chimneys at the East Boston Steam Pumping Station (EBSPS) as an emergency response to public safety issues. The demolition of these chimneys would constitute an adverse effect (36 CFR 800.9 (b)(1) and 950 CMR 71.05 (a)) to the National Register eligible property.

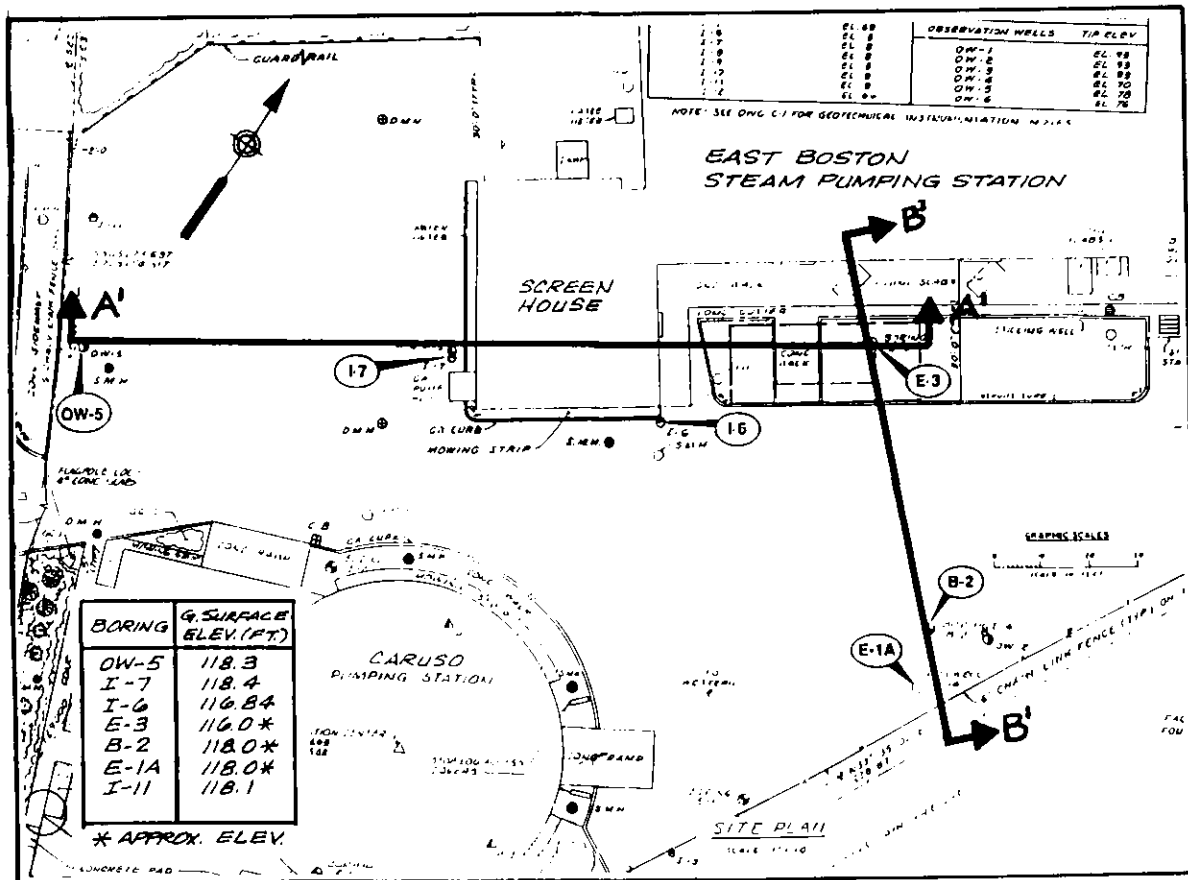
Figure 3-3 - Soil Profile Location Plan
East Boston Steam Pumping Station Historical, Architectural, Structural Assessment:
September 18, 1992

Five boring logs are available within the immediate vicinity of the EBSPS site. The borings were drilled in 1984 and 1986. The Soil Profile Location Plan, Subsurface Profile A-A, Subsurface Profile B-B (Figures 3-3, 3-4, and 3-5) show the boring locations and the subsurface profiles within the pumping station.
